Debris/Ice/TPS Assessment And Photographic Analysis For Shuttle Mission STS-33R

Charles G. Stevenson
NASA/Kennedy Space Center

DEBRIS/ICE/TPS ASSESSMENT
AND
PHOTOGRAPHIC ANALYSIS
OF
SHUTTLE MISSION STS-33R

November 22, 1989

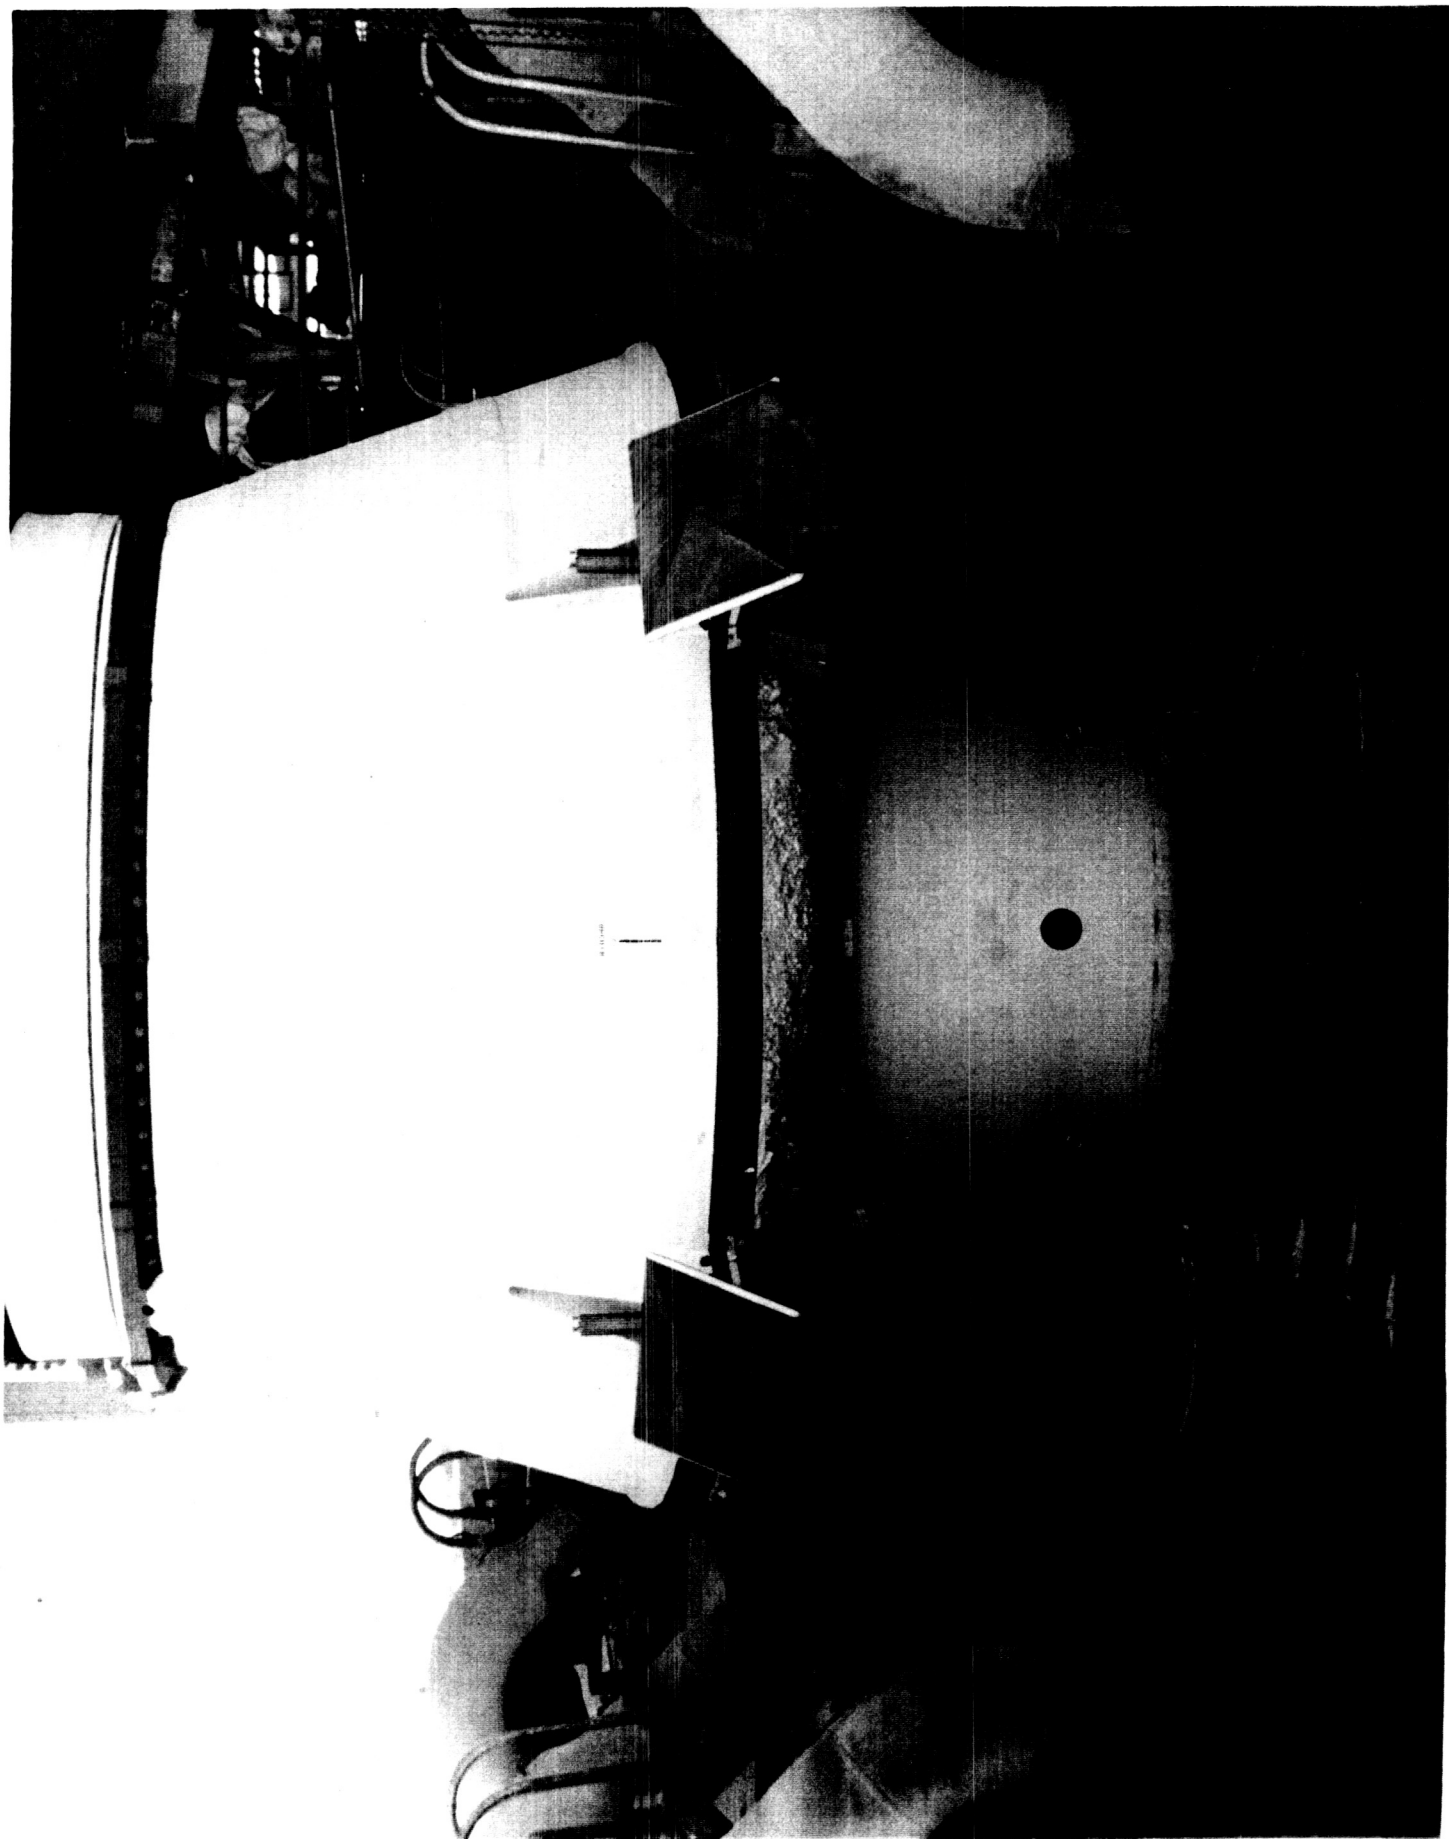
RH SRB secondary sound suppression water troughs were full of
water at T-24 hours in the countdown

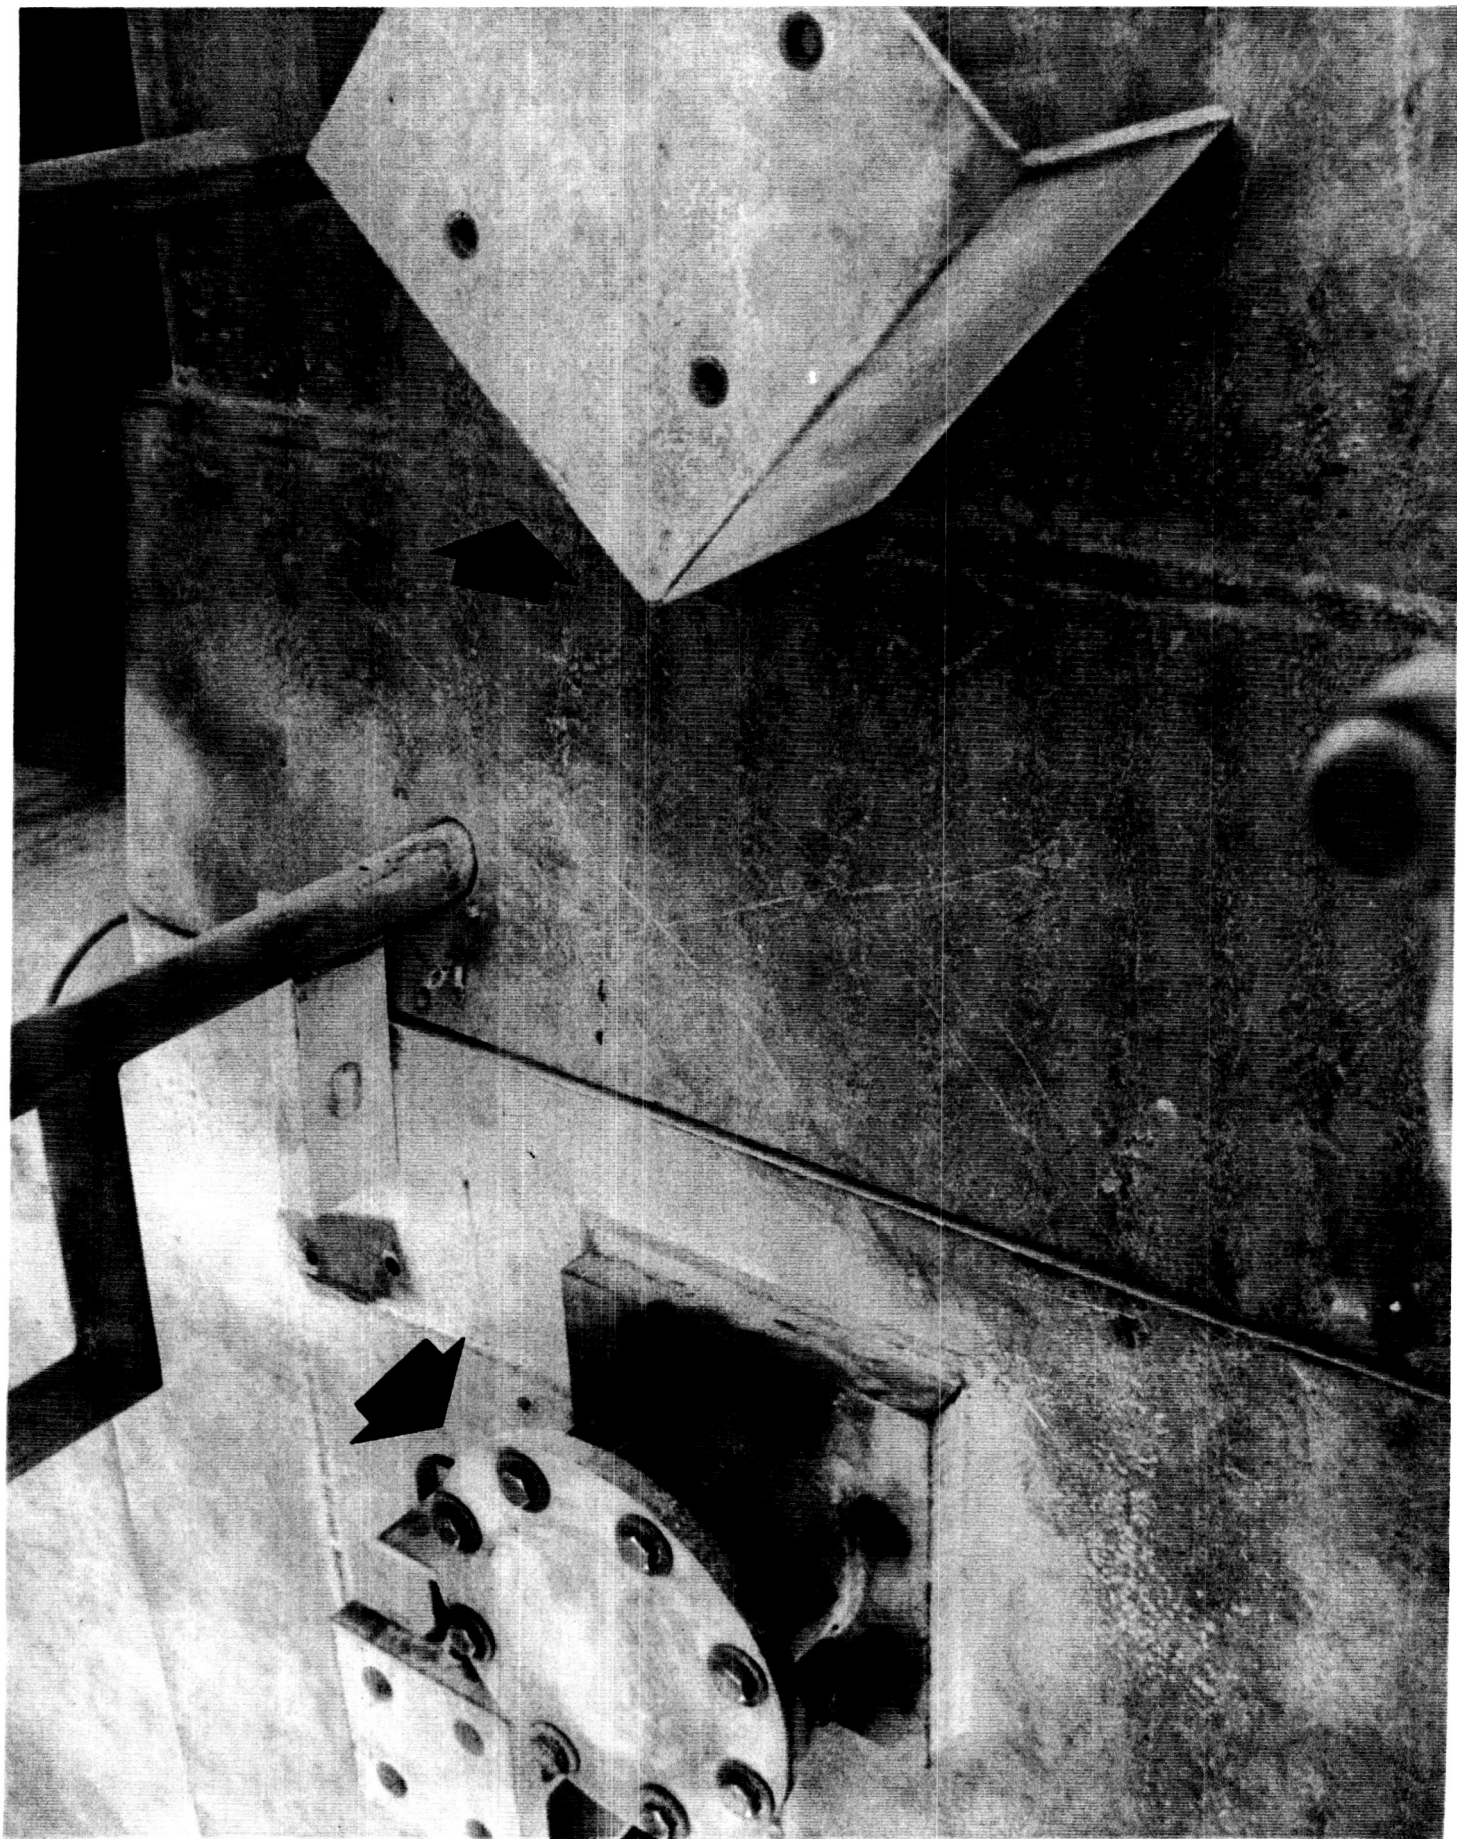
Bolts from portable hoist were left in the pedestal near the
RH SRB exhaust hole. Note loose deck cover on right side.

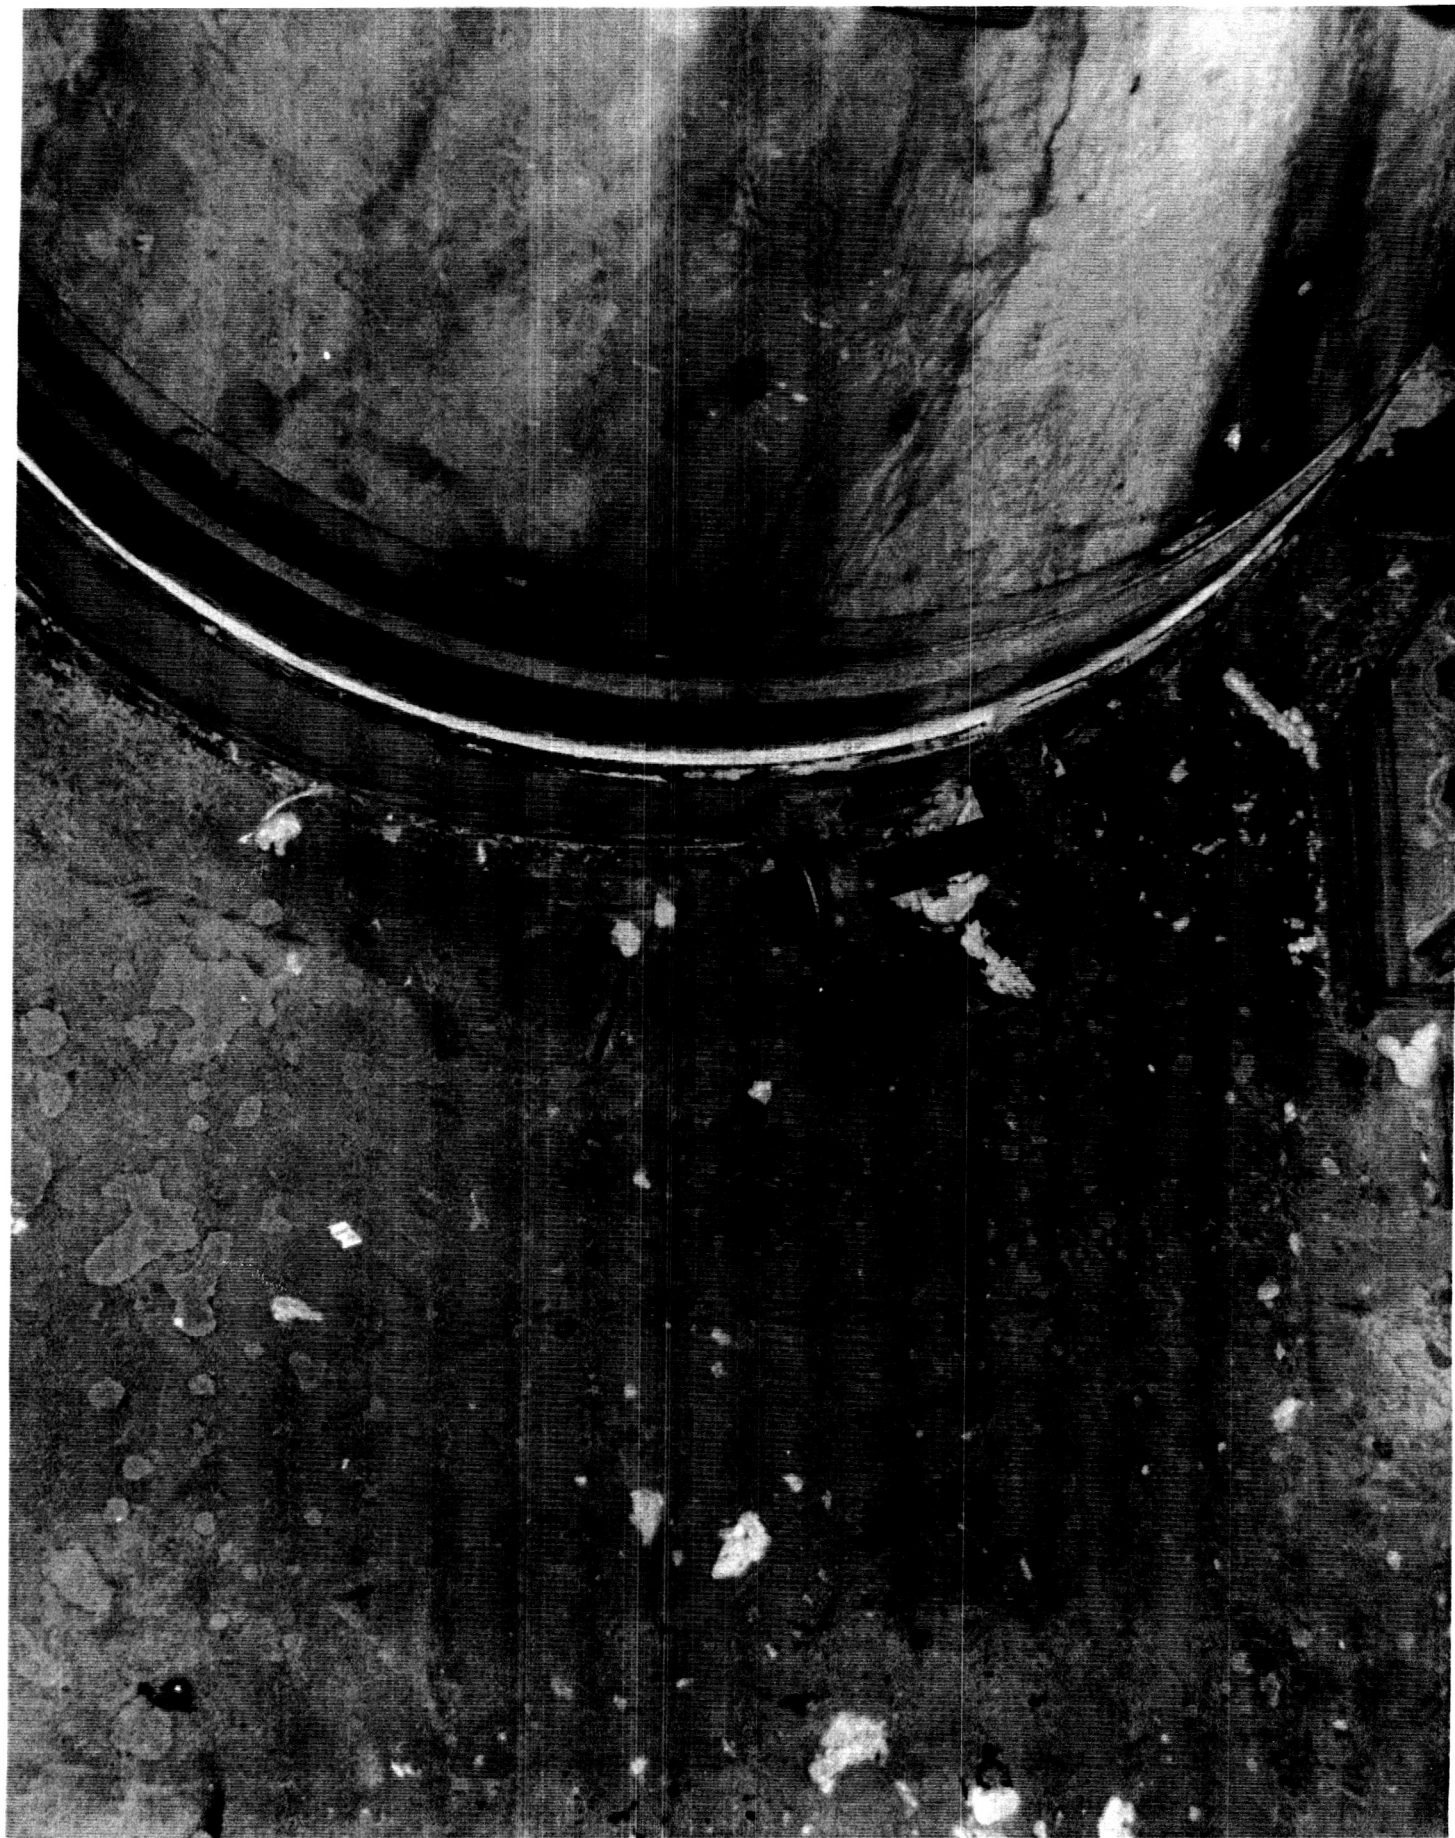
RTV correctly applied to instrumentation bands on the HDP base.
Note Instafoam and K5NA trimmings in HDP haunch area.

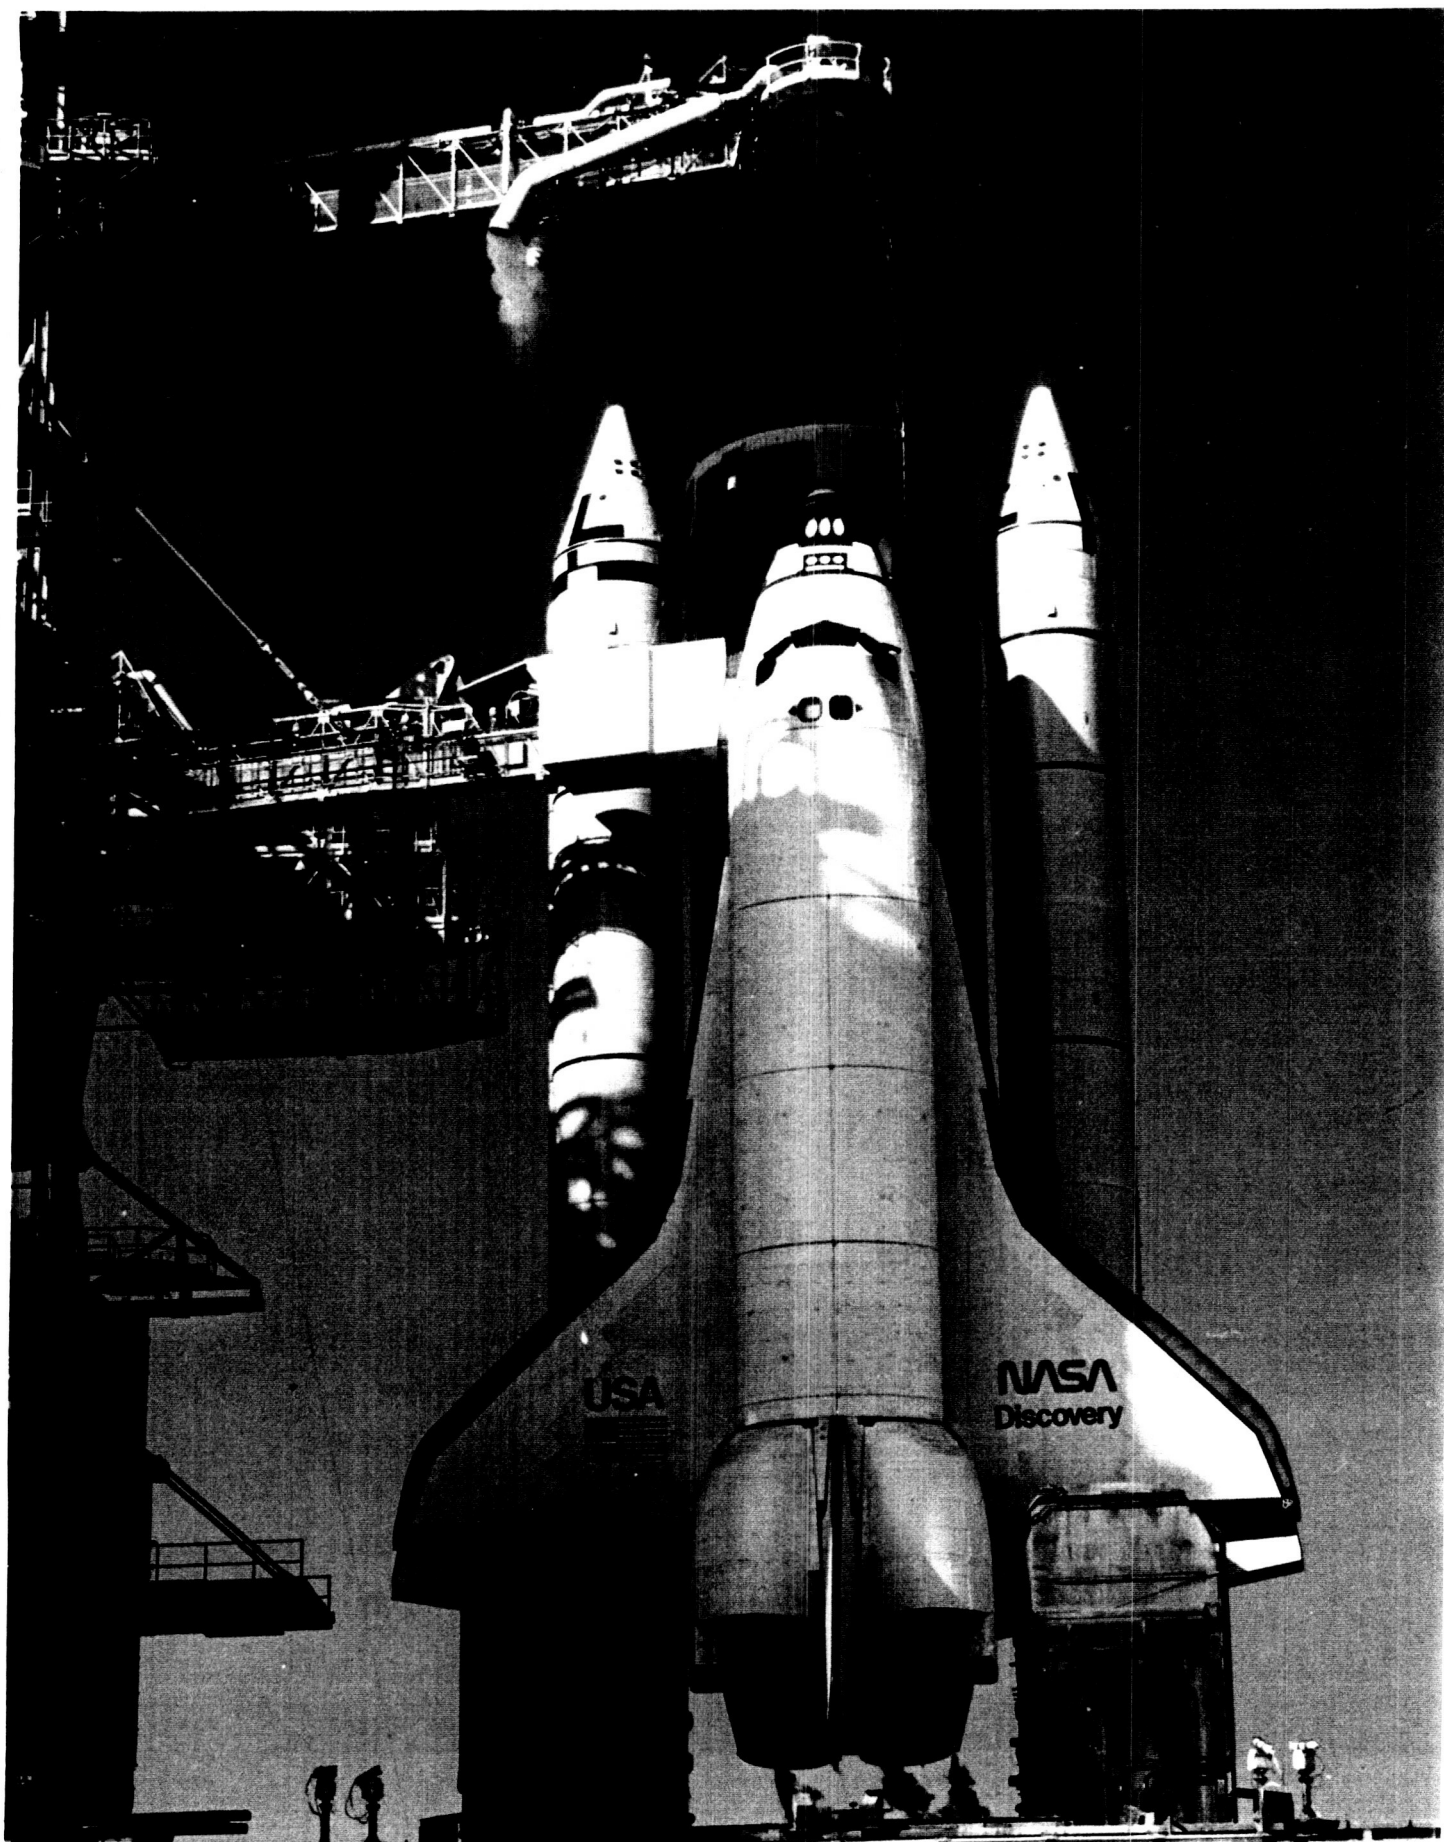
Overall view of SRB's and External Tank -Z side acreage
Note southerly wind blowing GOX vapors well away from vehicle

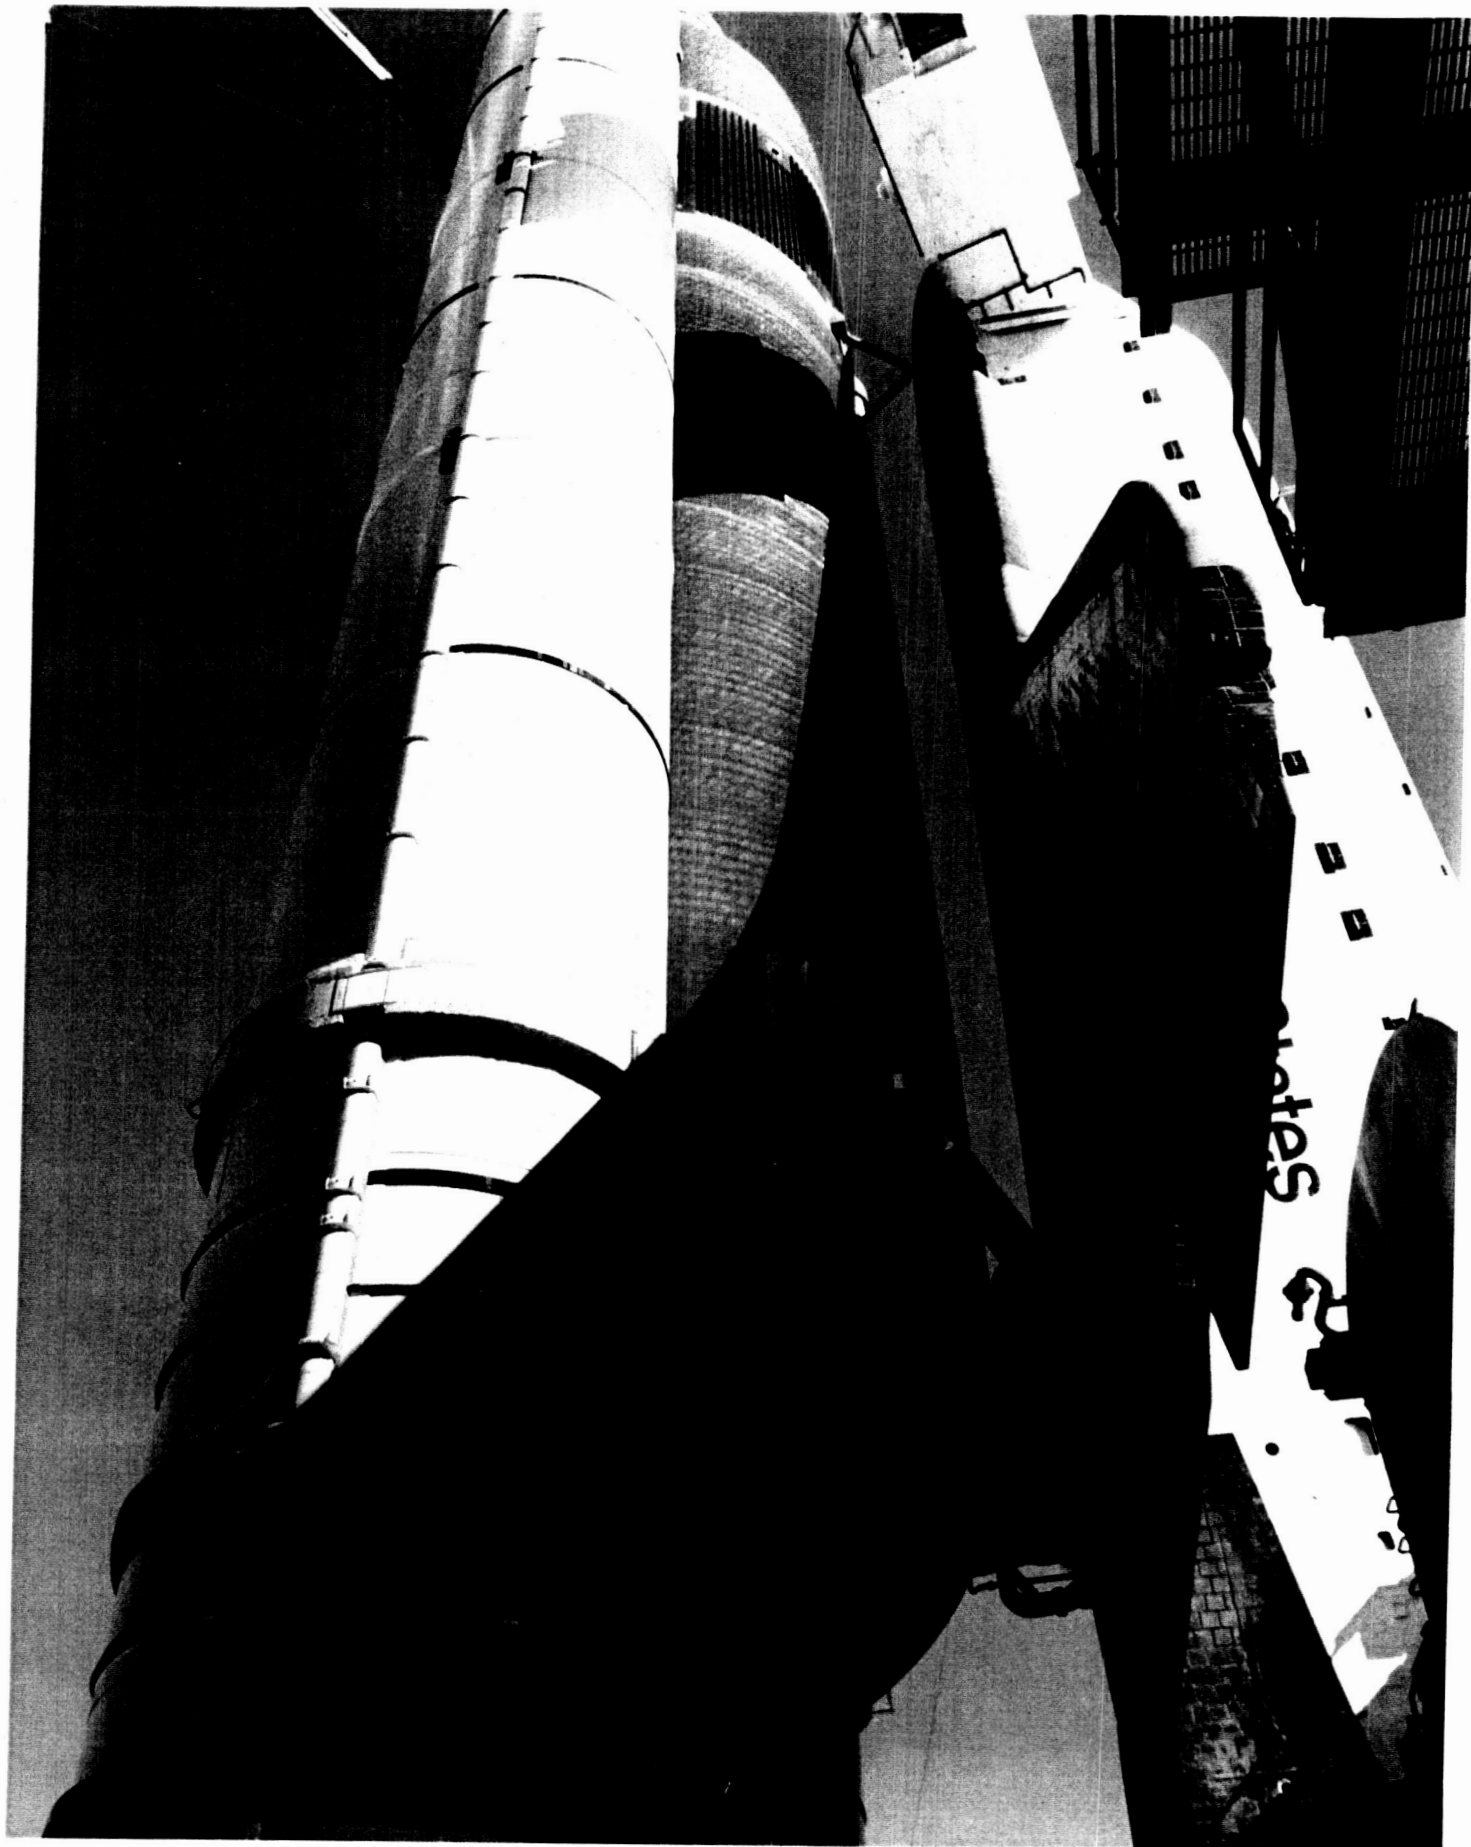
Overall view of vehicle -Y side. No ice or frost had accumulated on the ET acreage

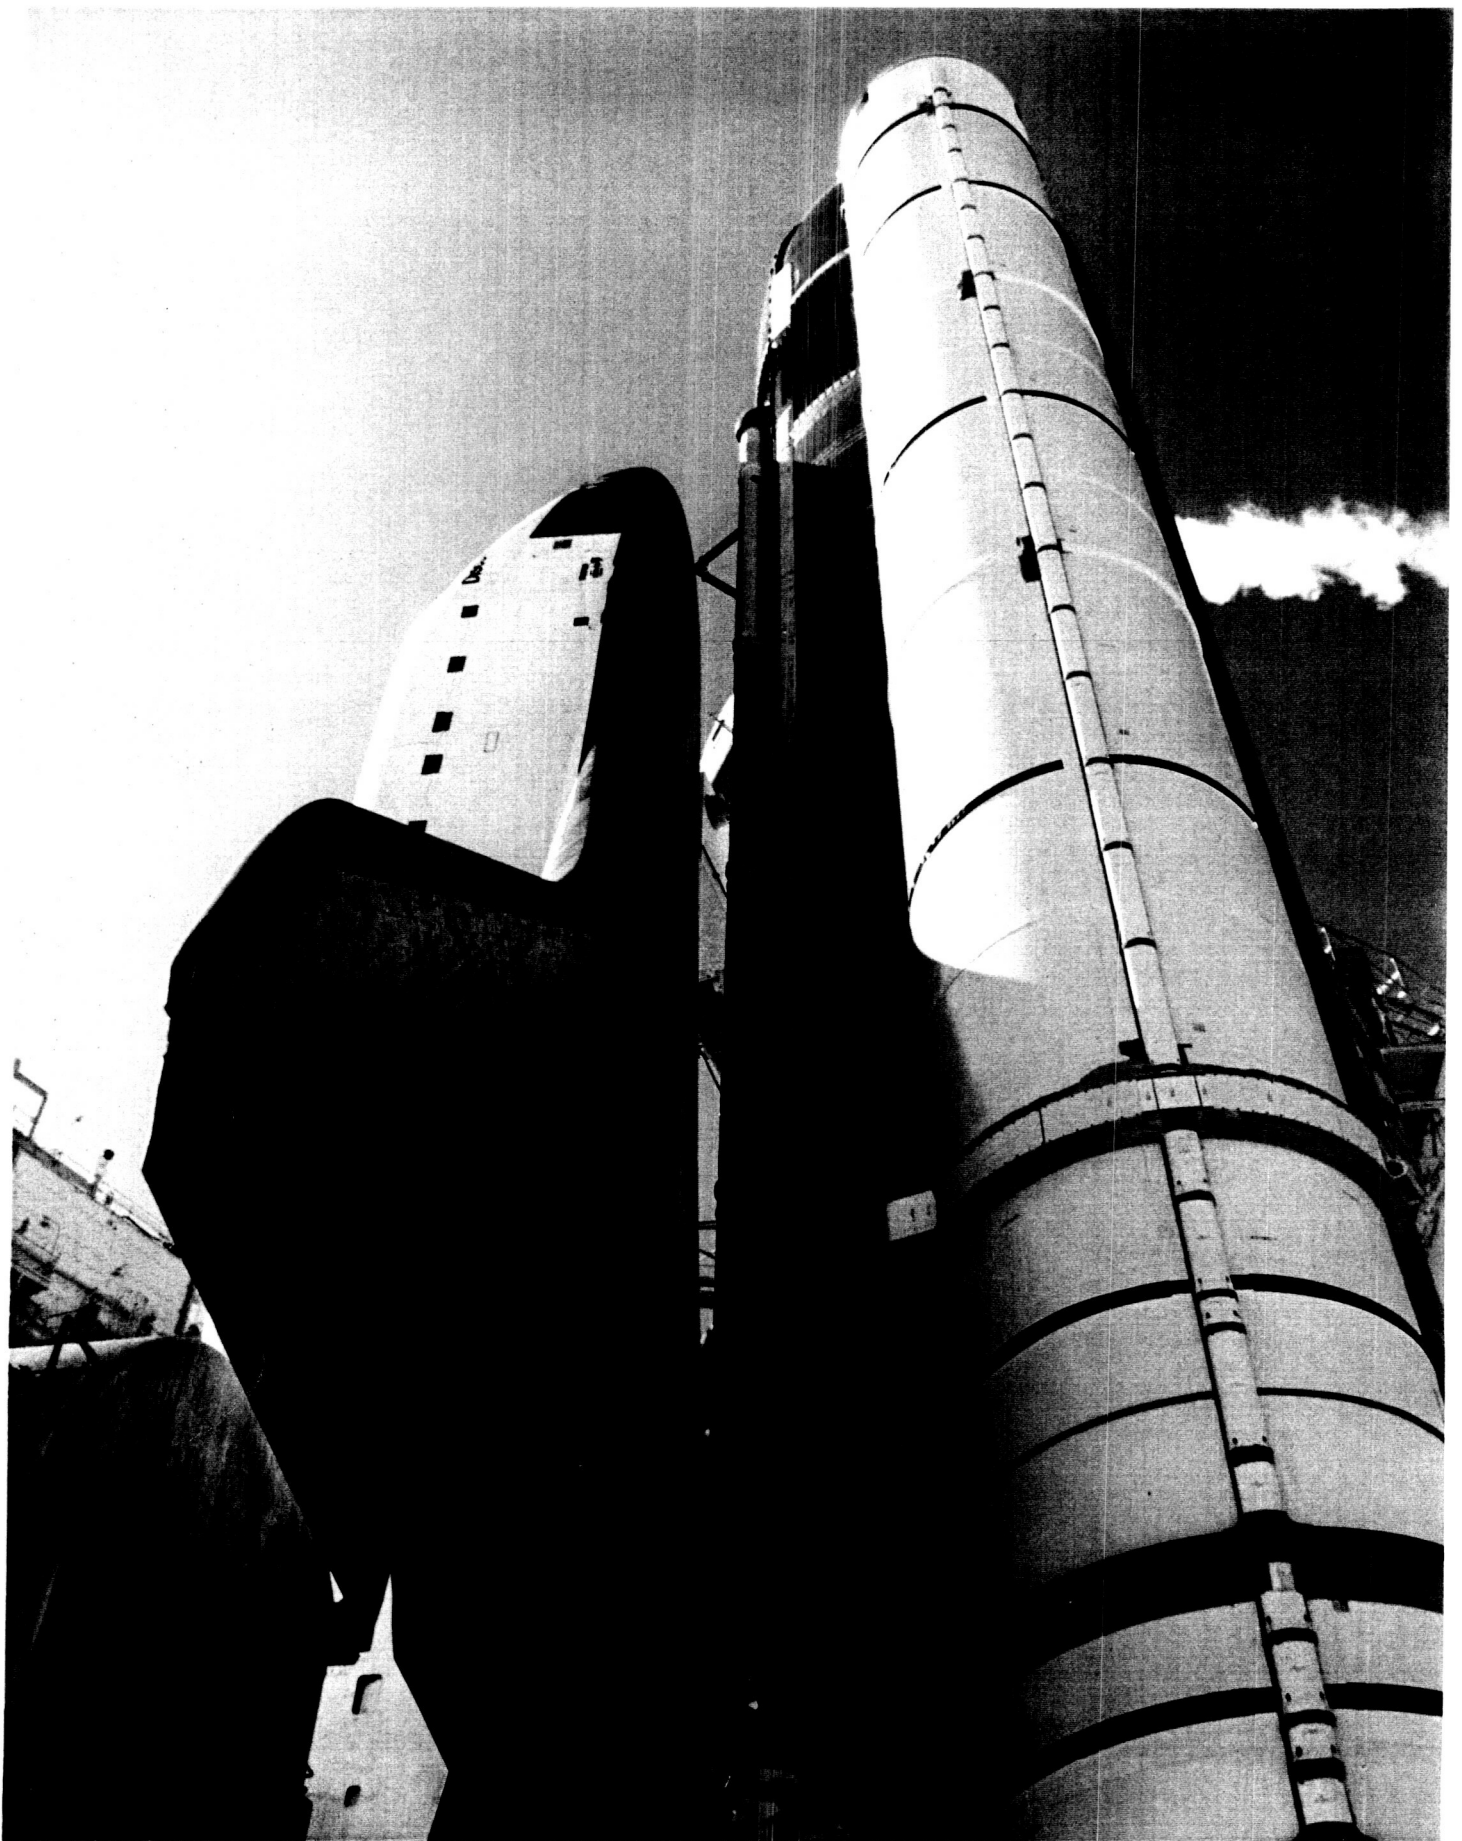
Overall view of vehicle +Y side. No ice or frost had accumulated on the ET acreage

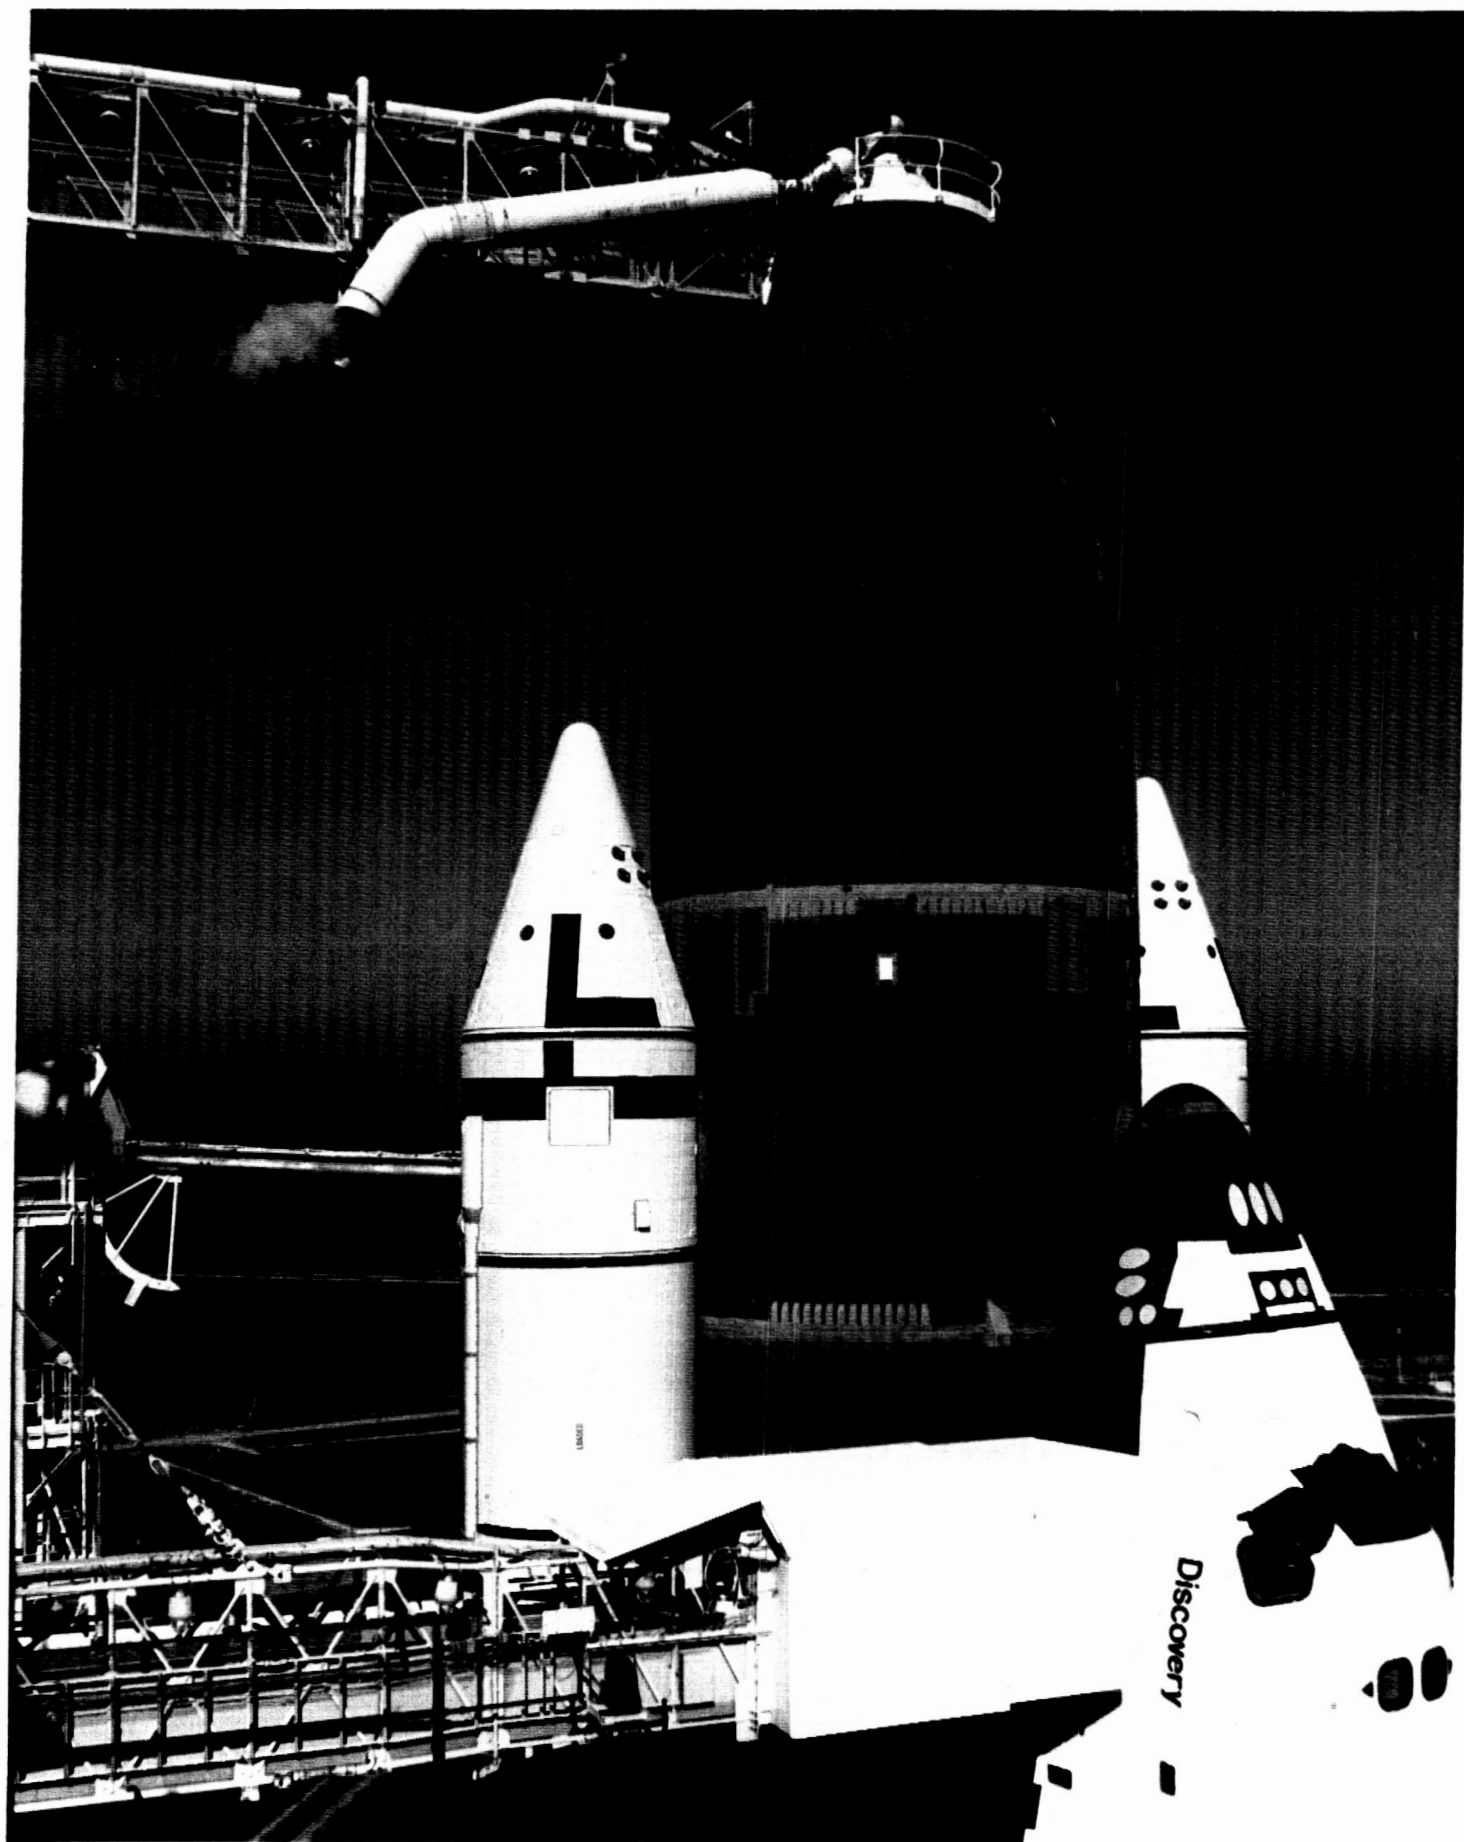
Condensate was light with no ice/frost on the ET L02 tank.
Note GOX vapors blown well away from vehicle by southerly winds

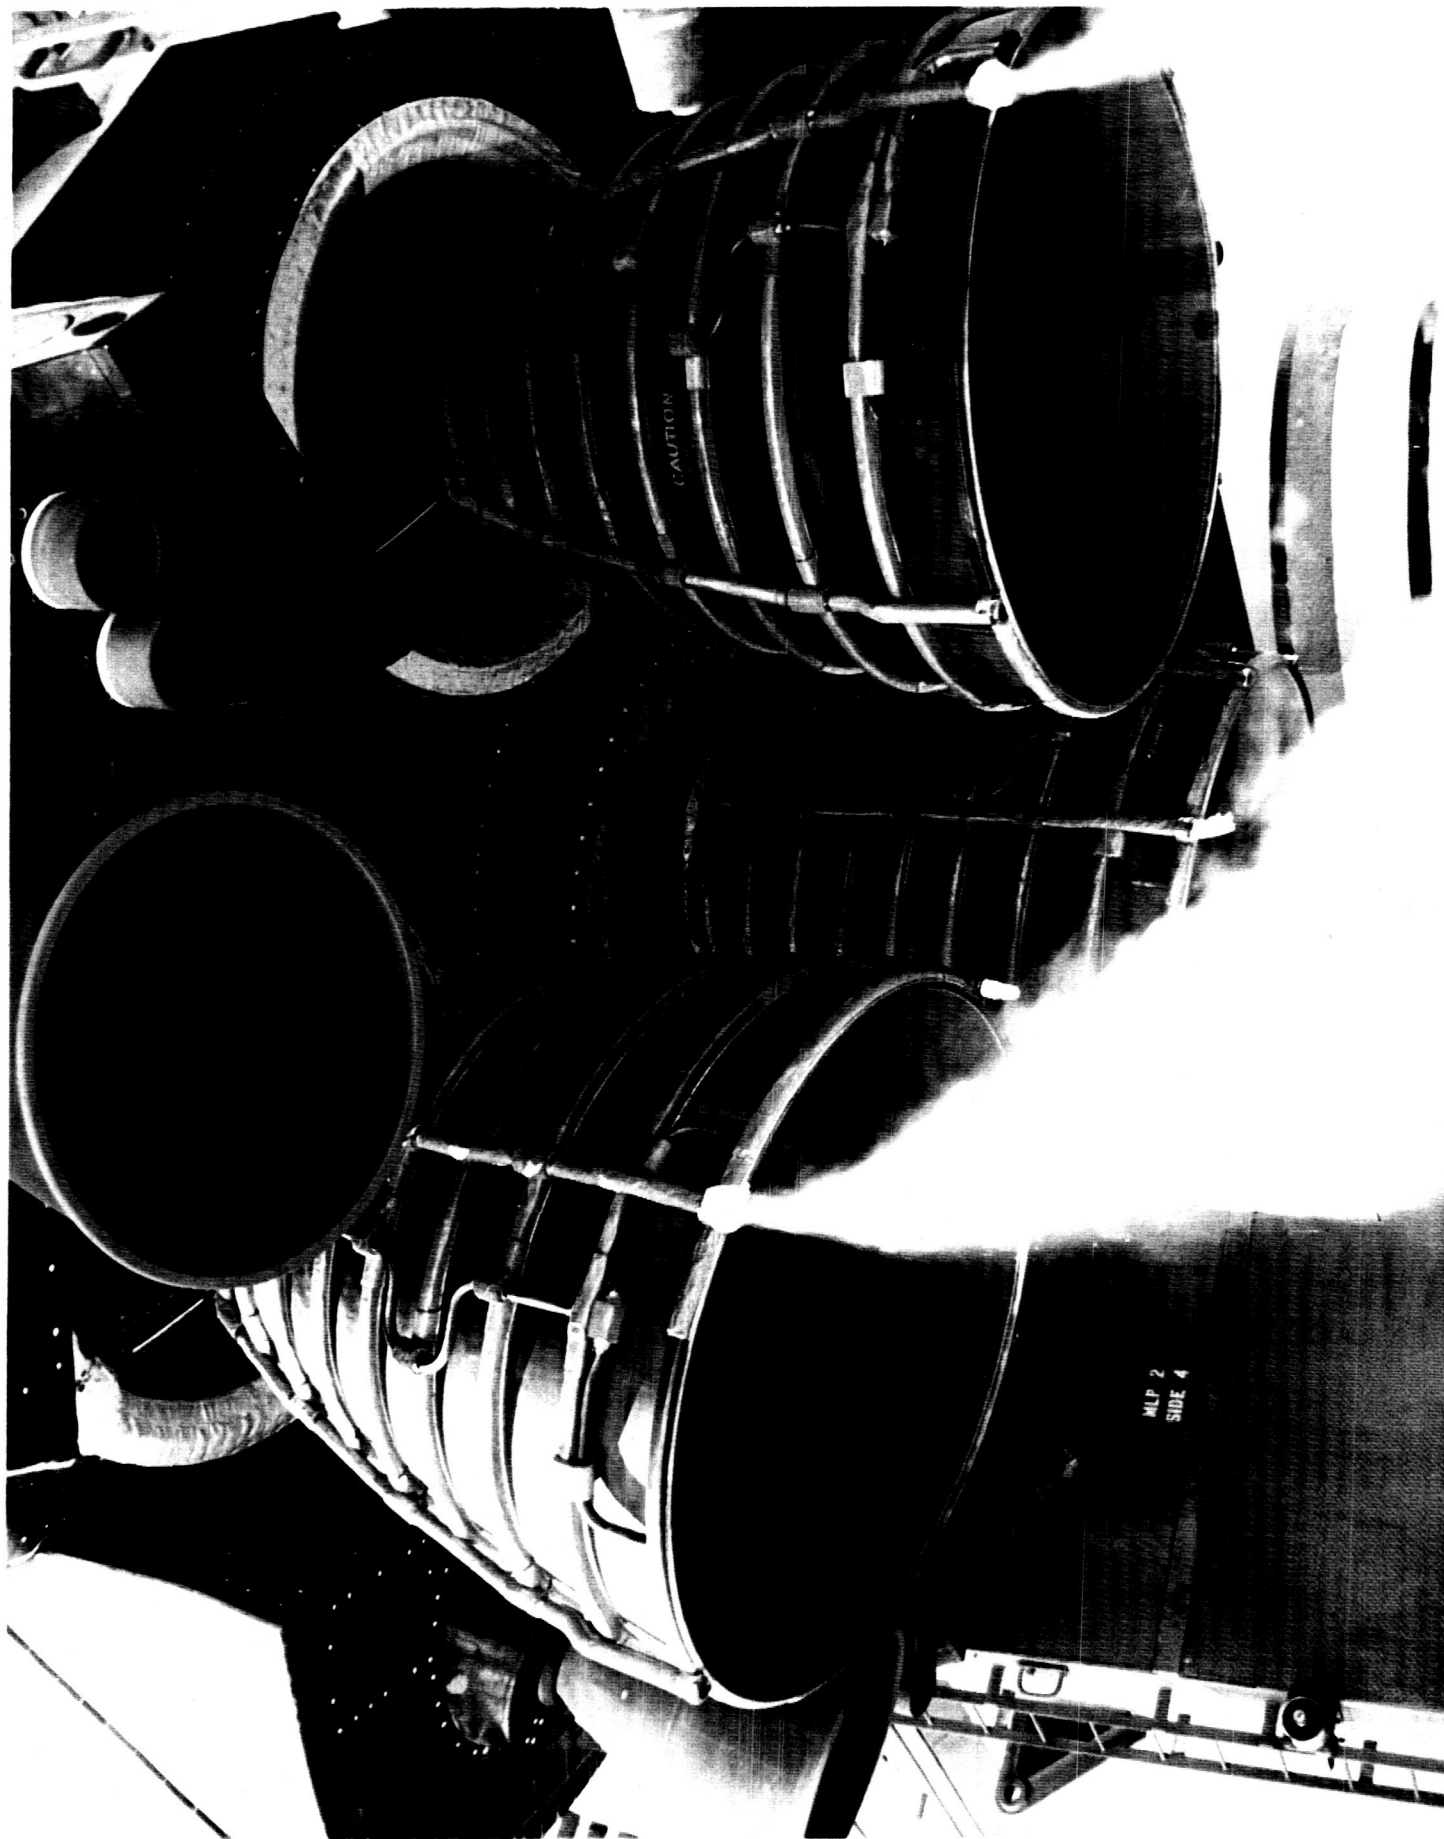
Overall view of Space Shuttle Main Engines. Frost had accumulated on the SSME #2 engine mounted heat shield interface
